Bujagali Dam – Dam Break Emergency Preparedness and Response Plan

PART 1 OF 2

Quick Reference Guide

PART 2 OF 2

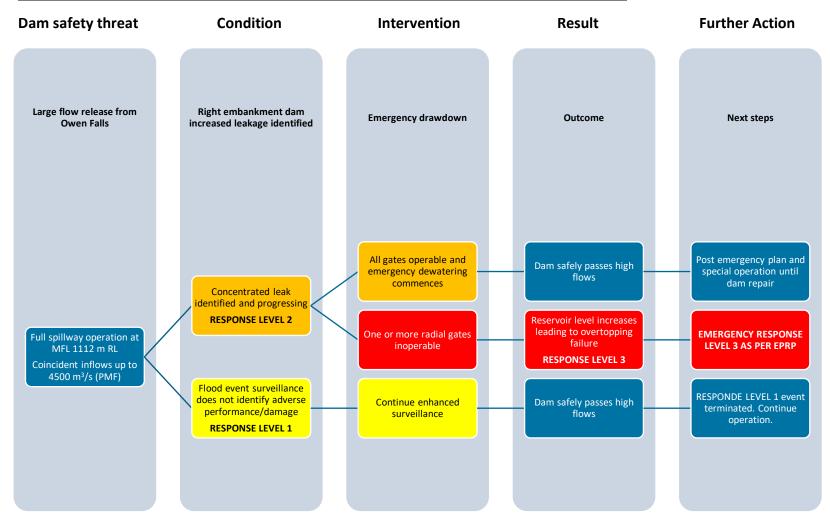
SIMPLIFIED EVENT TREE 1: Example high inflow/flood-induced potential failure mode (PFM)

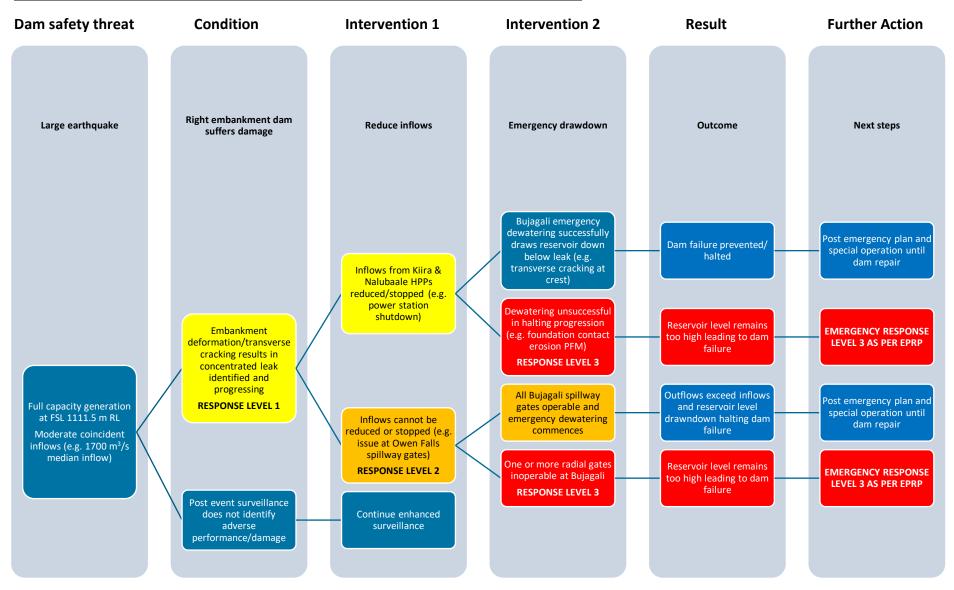
SIMPLIFIED EVENT TREE 2: Example earthquake induced potential failure mode (PFM)

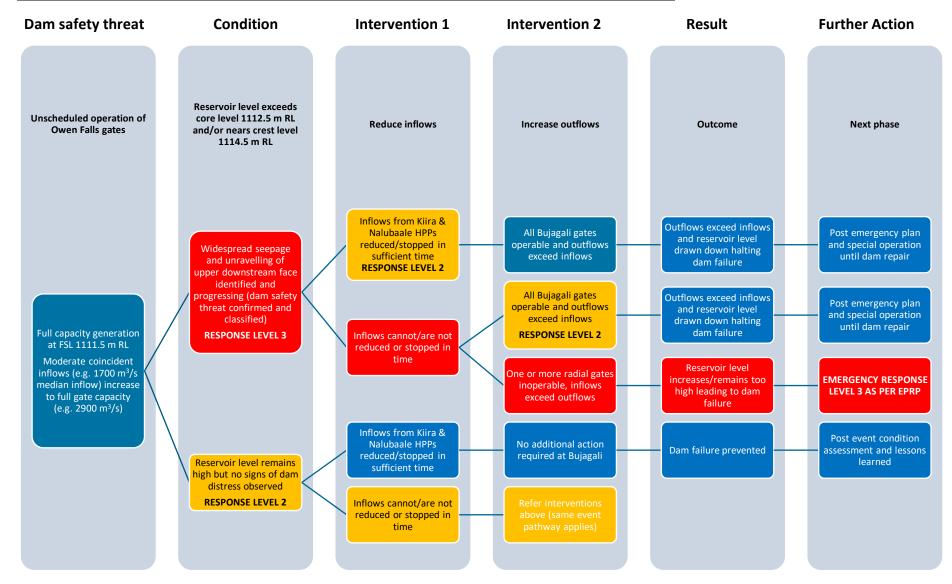
SIMPLIFIED EVENT TREE 3: Example operation induced potential failure mode - Unexpected inflows

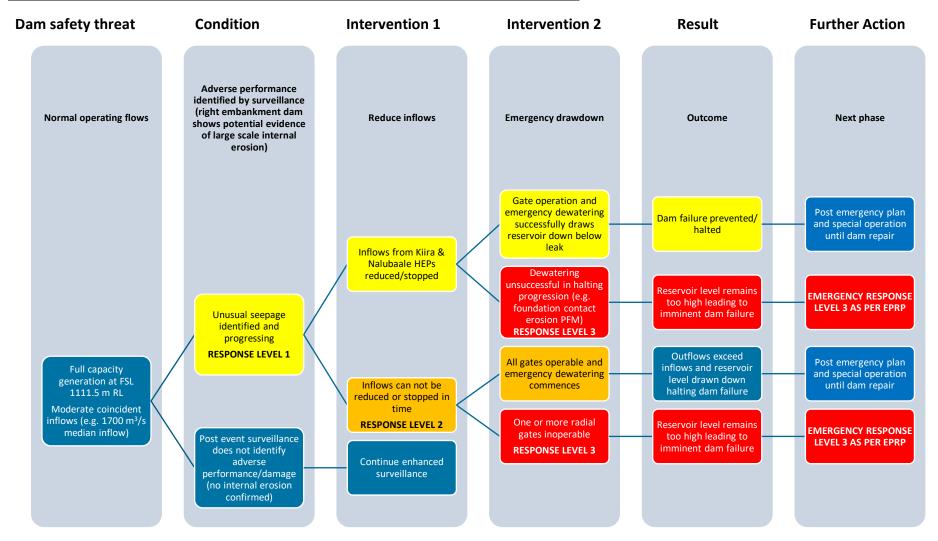
SIMPLIFIED EVENT TREE 4: Example of internal erosion induced potential failure mode

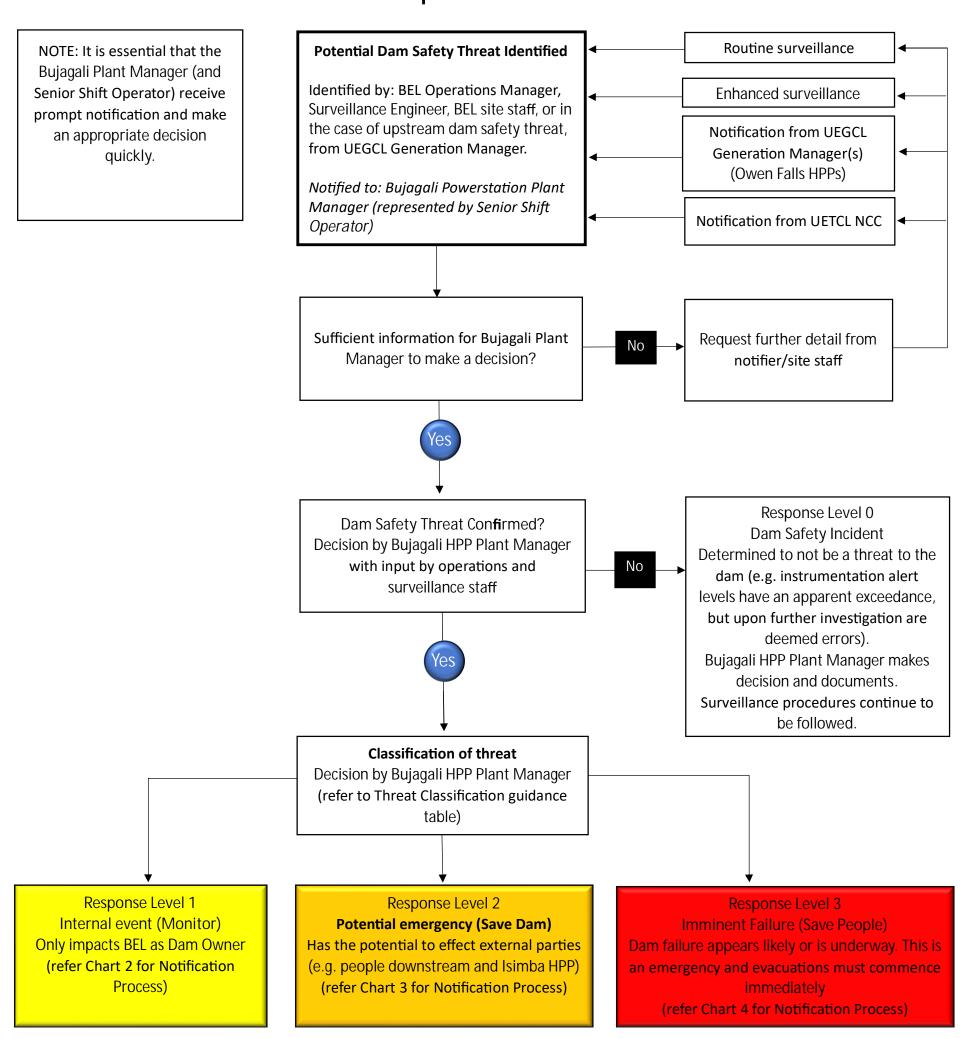
Chart 1: Dam safety threat identification and classification process

The processes for dam safety threat identification, classification, communication and notification for each response level are also presented in Charts 1 to 5 below.

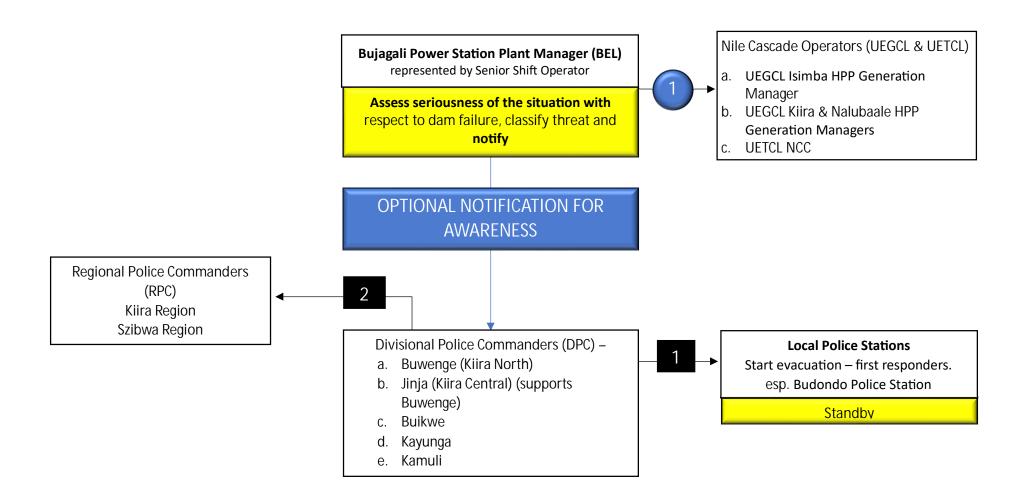
Chart 2: Notification & Actions – Response Level 1: Internal Event

Response Level 1: Monitor/Act (Internal event - serious dam safety threat identified, currently can be safely managed at the dam) - Be aware and take appropriate action at the Bujagali Dam.

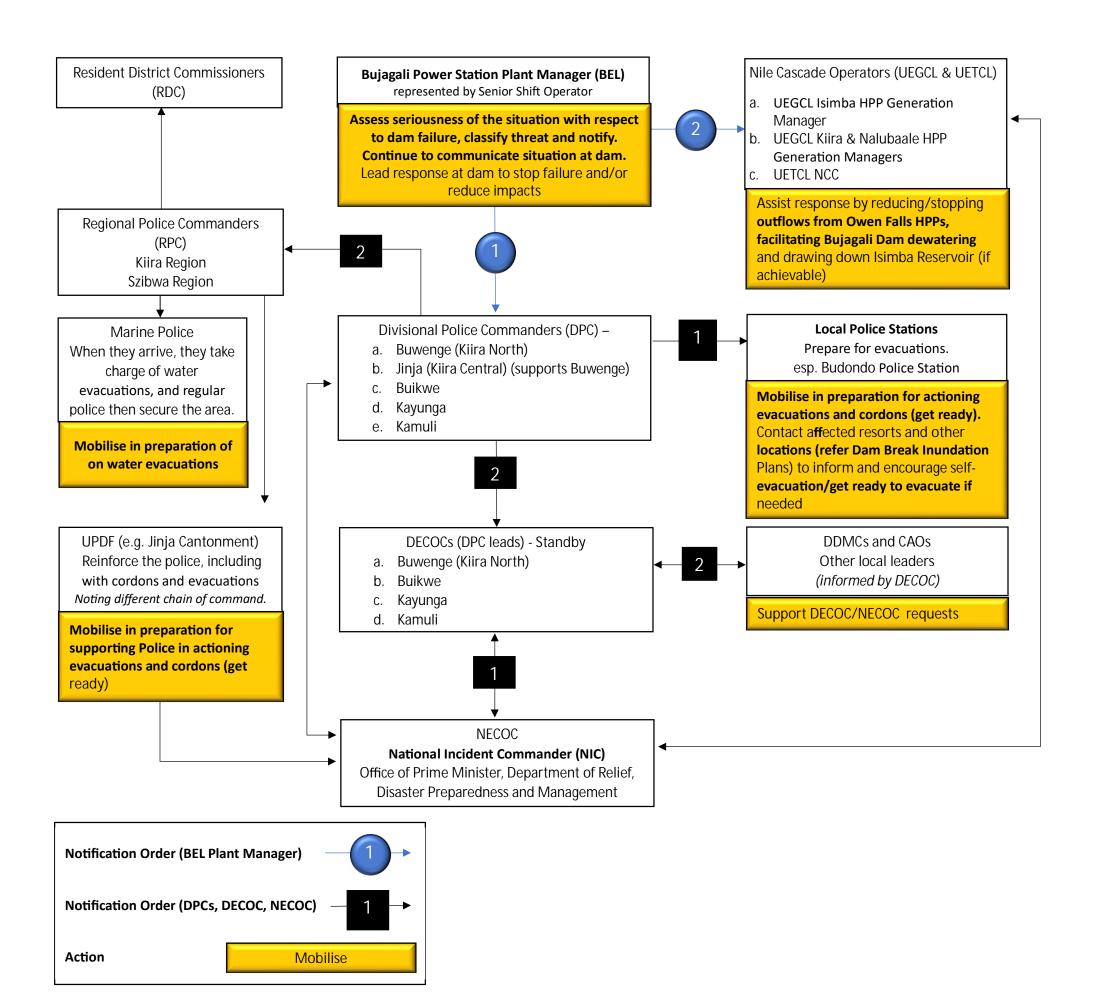
Response Level 2: Save Dam (Potential Emergency - Has the potential to affect others, action being taken to save dam)

Prepare to commence evacuations and emergency response

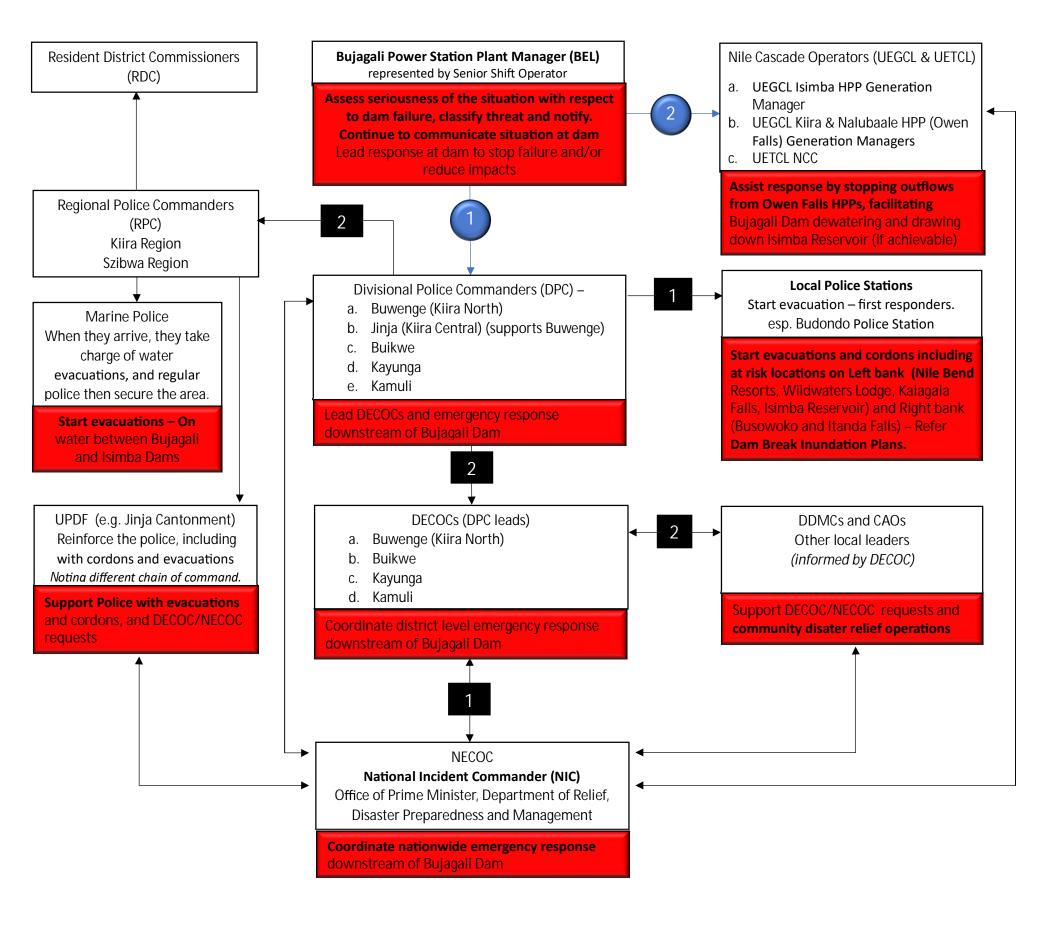
Chart 4: Notification & Actions – Response Level 3: EPRP Plan Implementation – Imminent Dam Failure

Response Level 3: Take action (Imminent Failure - Take action to save lives) - Commence evacuations and emergency response.

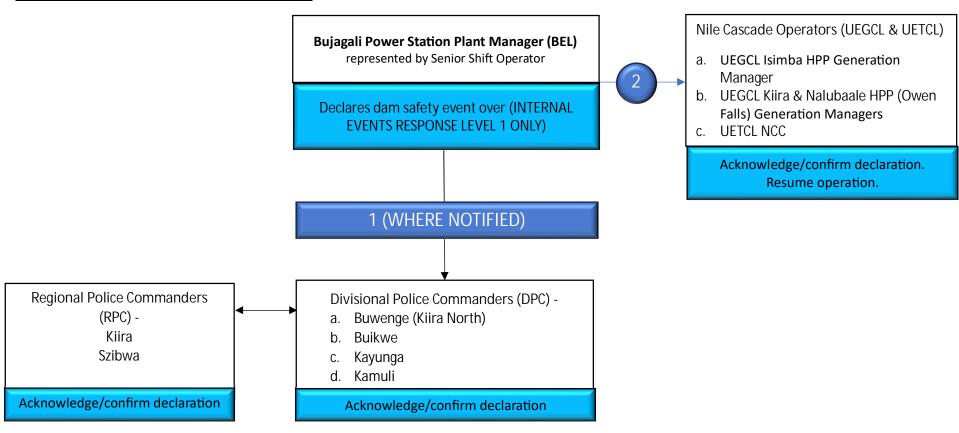
Chart 5: Notification & Actions – Event termination: Emergency response ends

INTERNAL EVENTS ONLY (RESPONSE LEVEL 1)

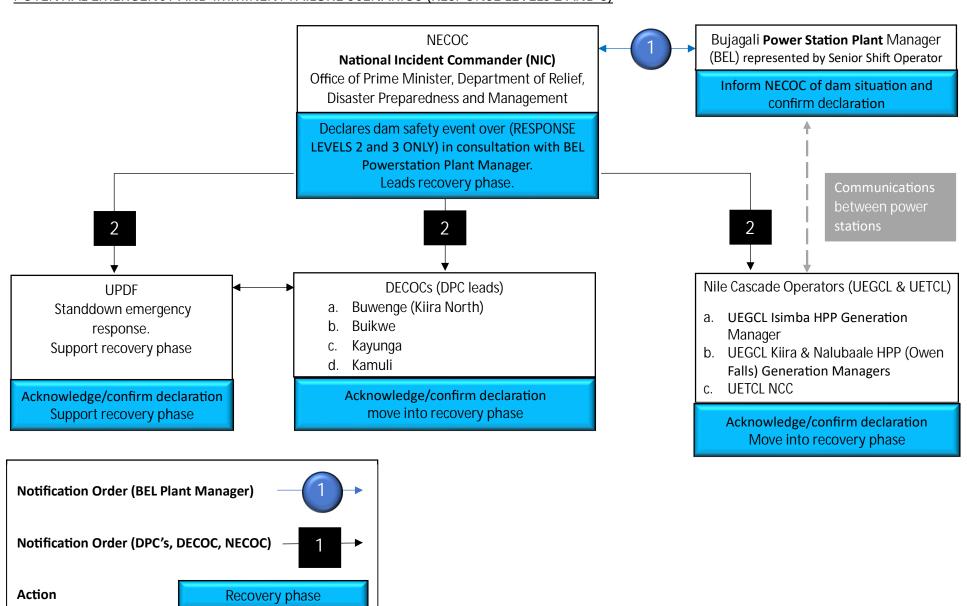
POTENTIAL EMERGENCY AND IMMINENT FAILURE SCENARIOS (RESPONSE LEVELS 2 AND 3)

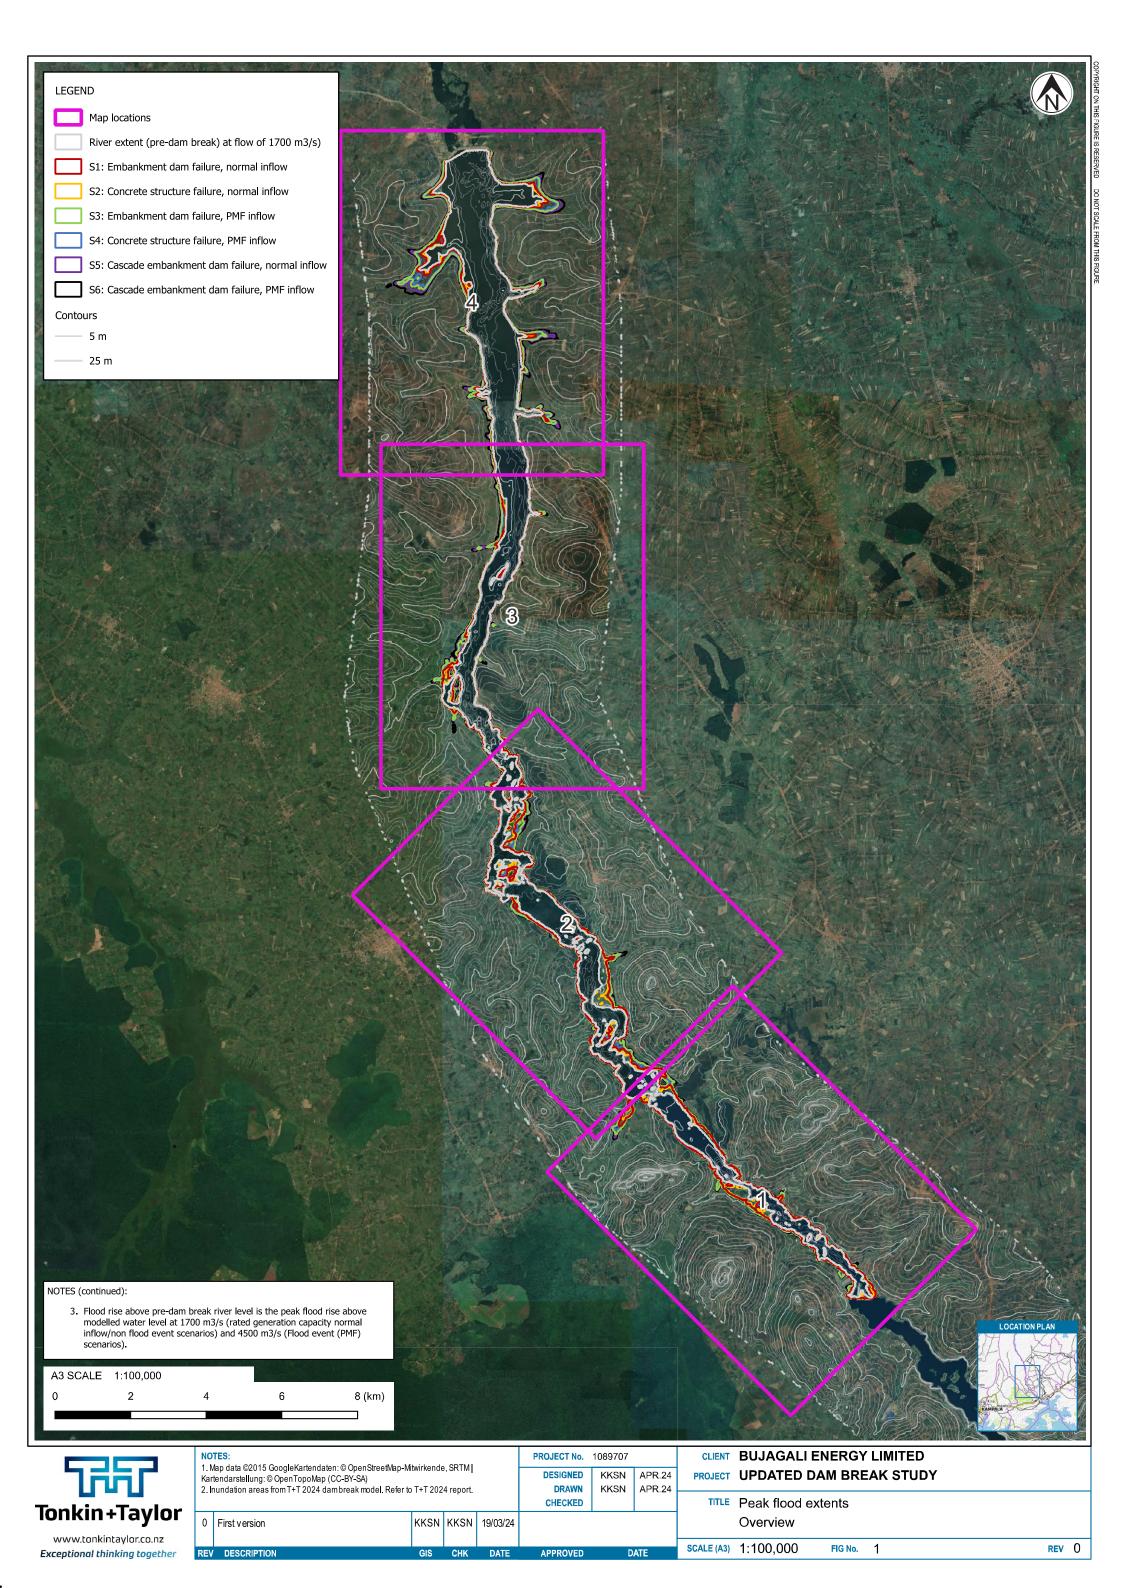
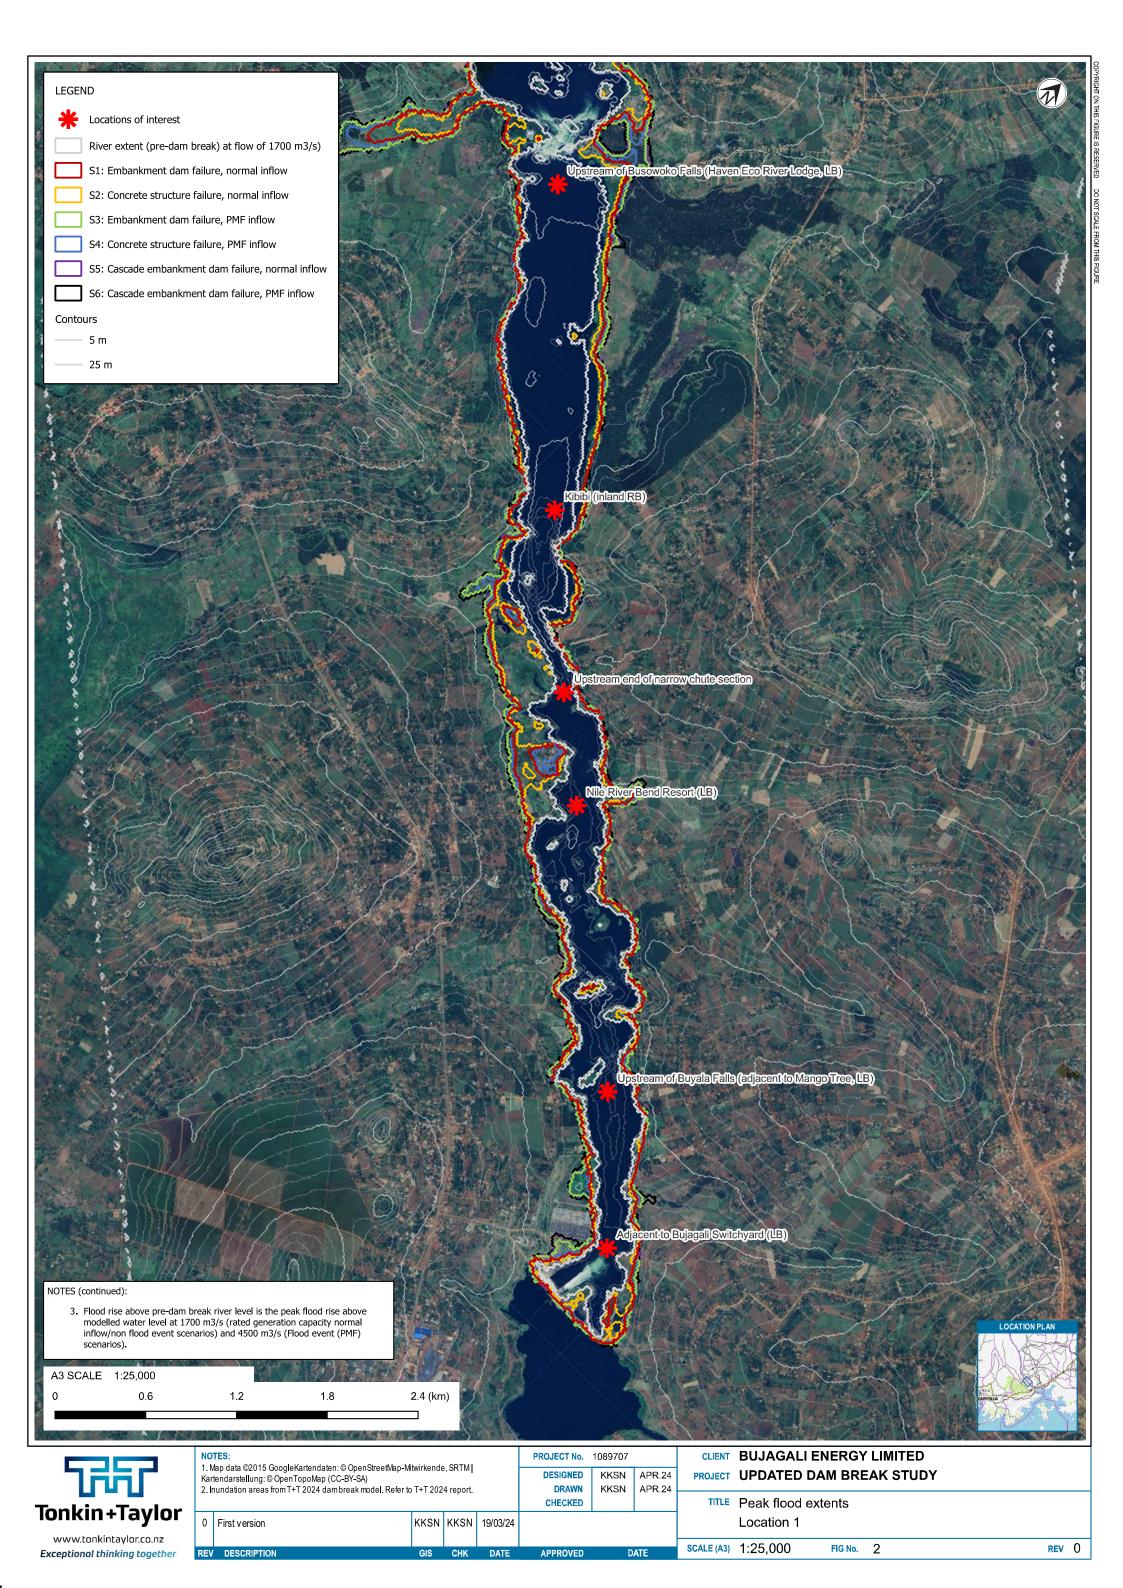
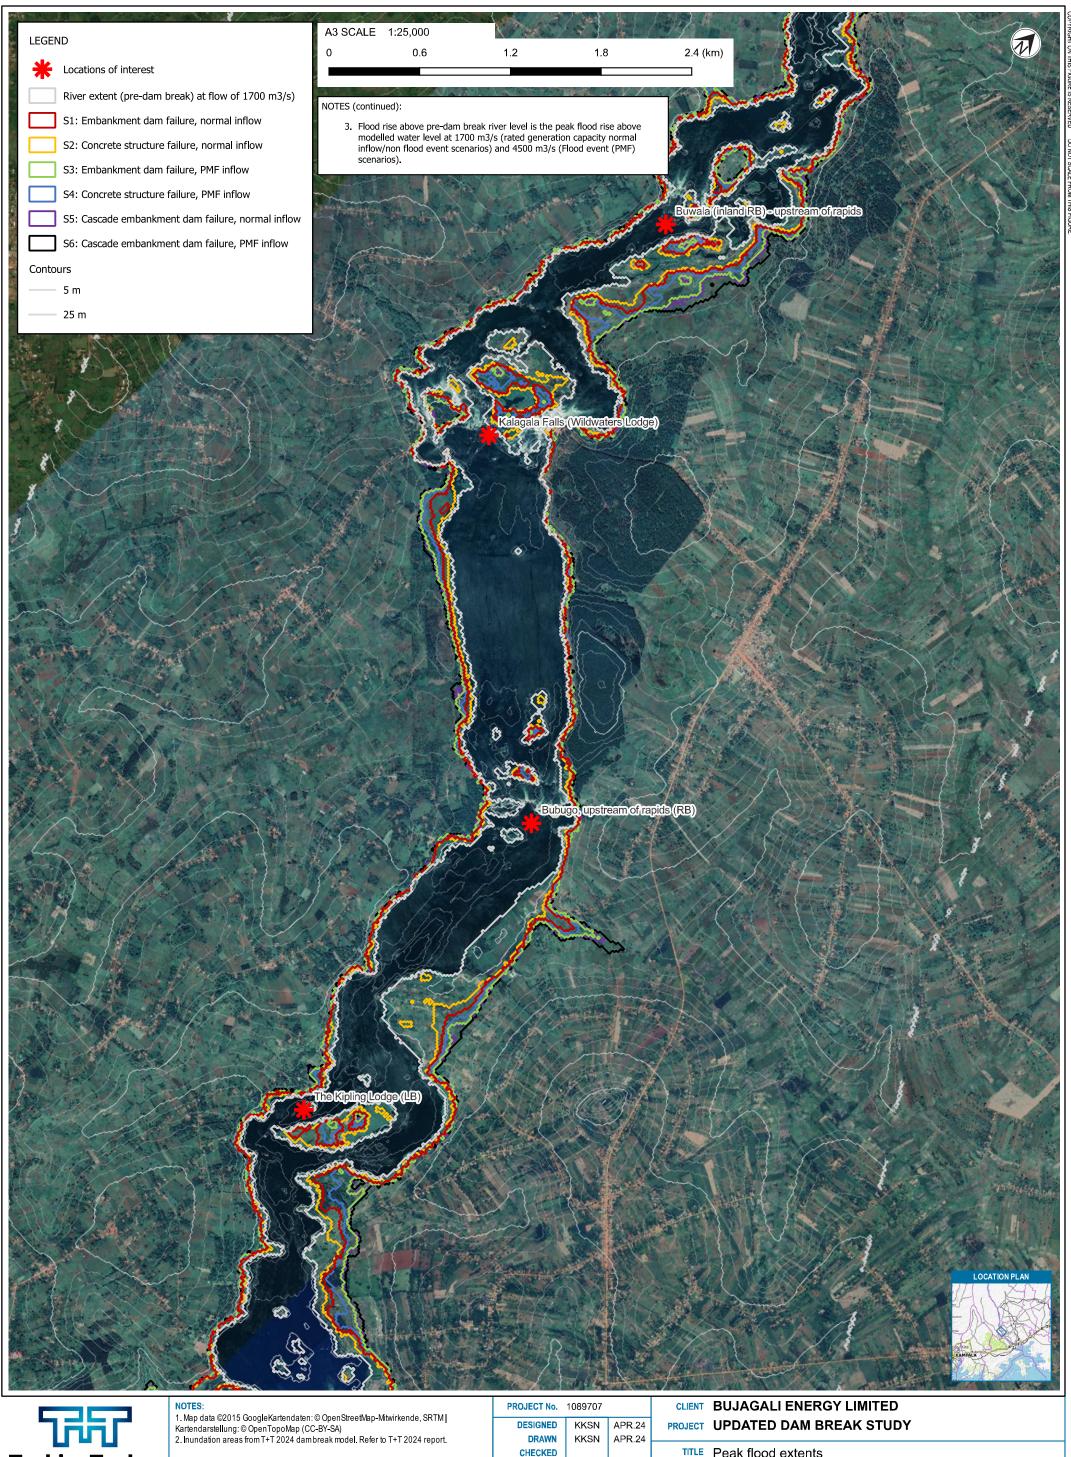
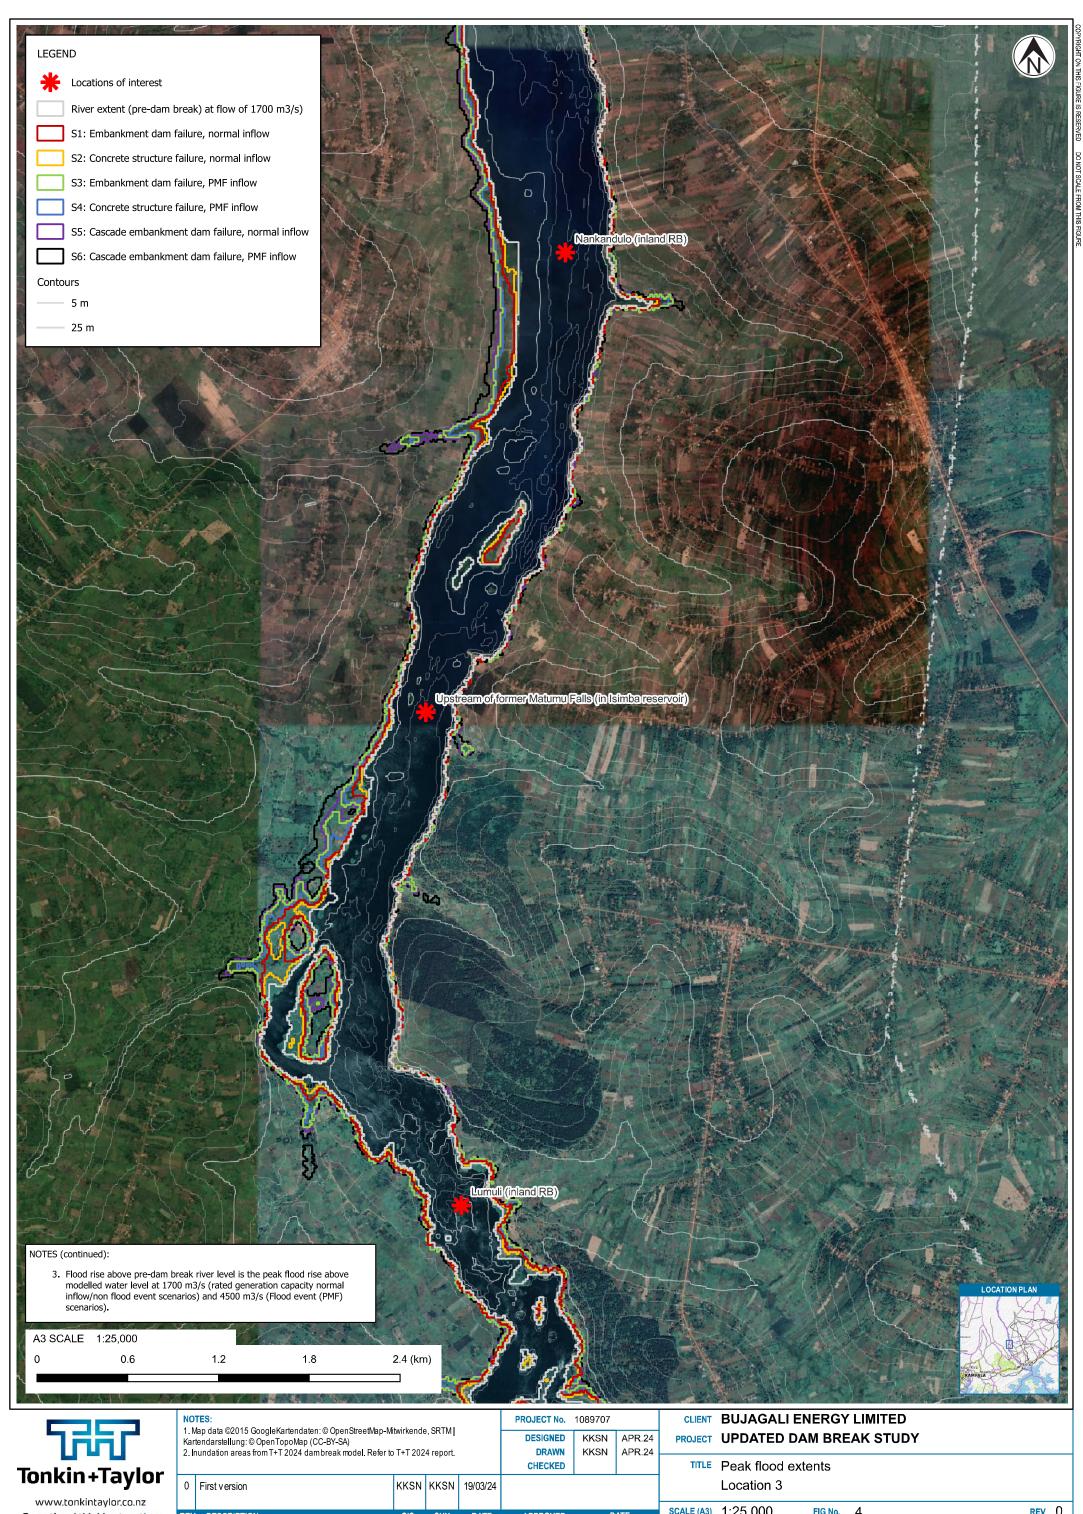
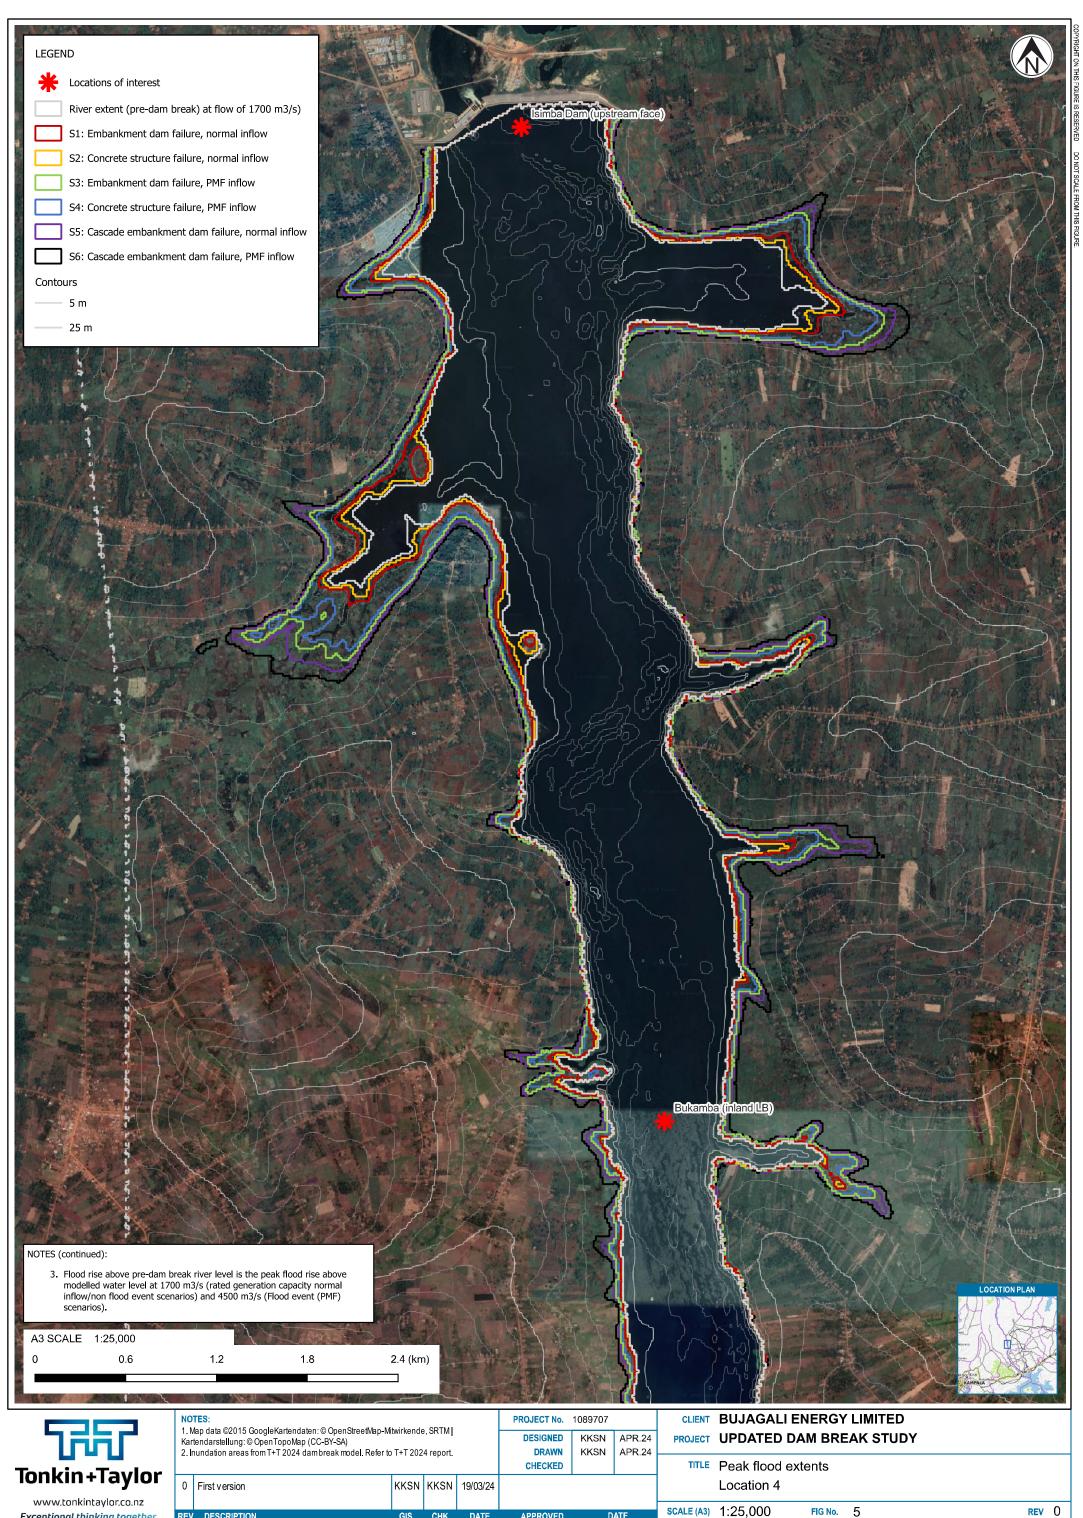
Flood hazard plans for the assessed potential breach scenarios are included in the following pages. These flood hazard plans indicate the extent of inundation for the modelled breach scenarios and should be treated as indicative to help inform the emergency response, noting they are based on a set of assumed conditions and the specifics of an actual dam breach event may be different.

Figure 1 shows the overall extent of the area covered by this emergency preparedness and response plan. Figures 2 to 5 present the modelled potential inundation extents for two dam breach scenarios i.e. a non-flood (sunny day) breach of Bujagali Dam and a high inflow (rainy day) cascade failure (Owen Falls breach followed by Bujagali breach). Further details of each figure are summarised in Table E below.

The **red line** inundation scenario (sunny day Bujagali embankment dam failure) shown on these figures should be used for dam safety events not caused by extreme high inflows (e.g. when the downstream areas are not already flooded from high outflows from Lake Victoria). Under Response Level 3 (and potentially Response Level 2) these areas are to be evacuated.

The **blue line** inundation scenario (flood-induced (rainy day) cascade failure) shown on these figures should be used for dam safety events when the Victoria Nile Cascade dams are all releasing high discharges (likely coincident with high Lake Victoria levels) and a cascade failure is anticipated or occurring. These potential inundation extents assume the Victoria Nile River downstream of the Bujagali Dam is already in flood prior to a potential dam break. Under Response Level 3 (and potentially Response Level 2) these areas are to be evacuated.

Figure Number	River/Area	Description
Figure 1	Victoria Nile downstream of Bujagali Dam to Isimba Dam	Shows the overall extent of the area covered by this emergency preparedness and response plan
Figure 2	Bujagali Dam to Busowoko Falls	Modelled inundation extents for (i) A non-flood
Figure 3	Busowoko Falls to Kalagala/Itanda Falls	(sunny day) dam breach of Bujagali Dam with normal operational flows in the Victoria Nile,
Figure 4	Kalagala/Itanda Falls to Isimba Reservoir	and (ii) A cascade failure caused by an extreme
Figure 5	Isimba Reservoir	flood (PMF) which causes a dam break at Owen Falls that results in a breach of Bujagali Dam.

Table F Dam breach flood hazard – Warning times for select locations (refer Figures 1 to 5)

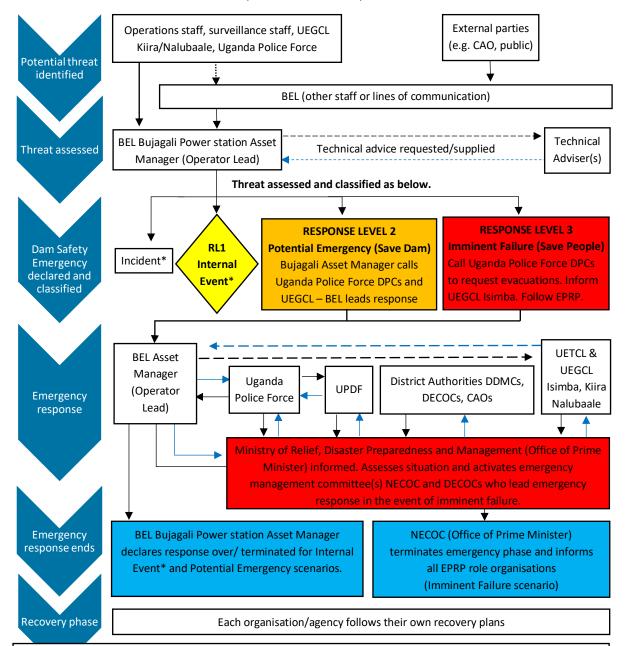
Each organisation with a role in the EPRP should have their own internal communications plan that is specific to their organisation and reflects the requirements of this EPRP. The overview communications process is presented below and shows the communication flow at each step of an event as the event progresses (black lines show primary communication flows, blue lines show responses, dashed lines are secondary lines of communication). Detailed notification flow charts are included in the Quick Reference Guide (Part 1 of this EPRP).

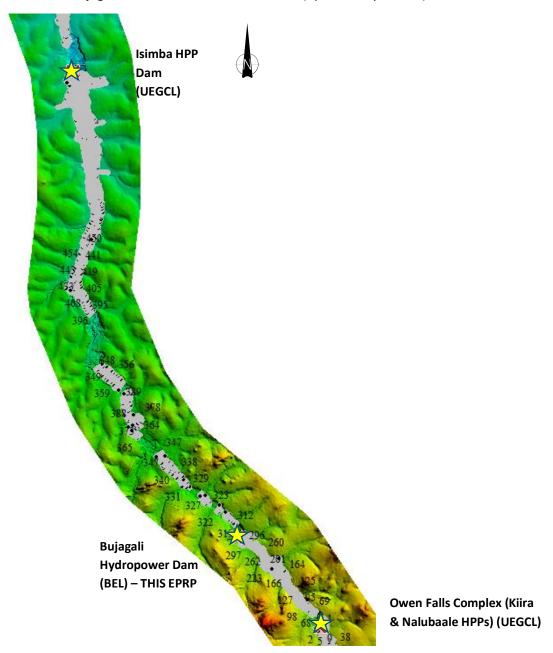
Figure 1.1 Emergency response area covered by this EPRP (Between Bujagali and Isimba Dams).

A high-level plan of the area covered by this EPRP is presented below in Figure 1.1. The area covered is from the Bujagali Dam down to the Isimba Dam (operated by UEGCL).

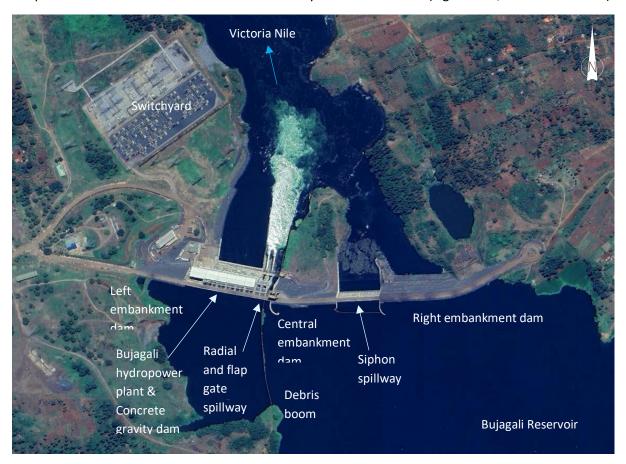
Figure 1.3 General arrangement/layout of the Bujagali Hydropower Dam (aerial sourced from Google Earth)

Layout figures and a summary description of the Bujagali Hydropower Dam along with example photos are provided below to assist with familiarisation by users of this EPRP (Figures 1.3, 1.4 and Table 1.1).

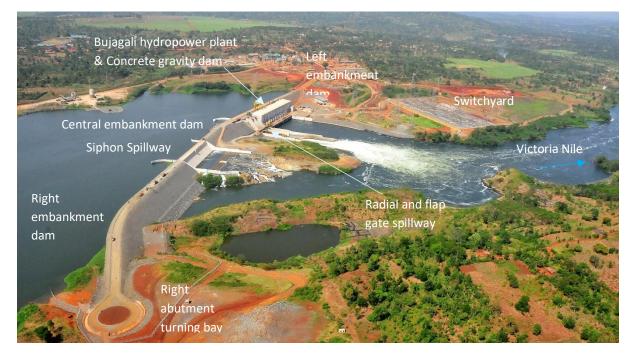
Figure 1.4 Annotated aerial photo of the Bujagali Hydropower Dam

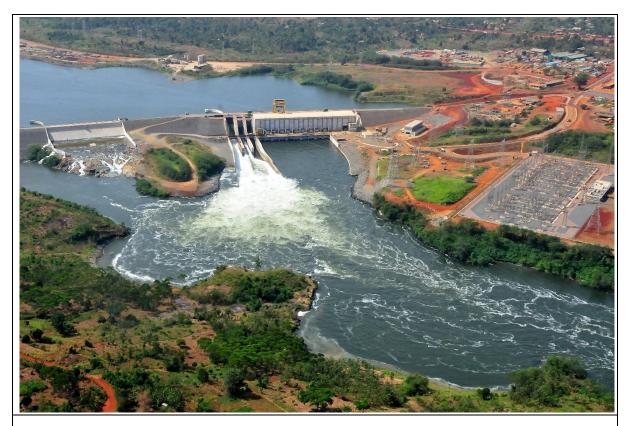
Oblique aerial photo of scheme from downstream (looking upstream from left to right, siphon spillway, gated spillway (flap gate and one radial gate in operation), power station/gravity dam and left embankment dam.

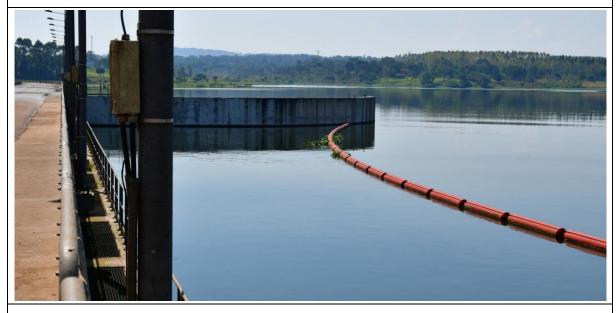
Upstream face (power station inlet)

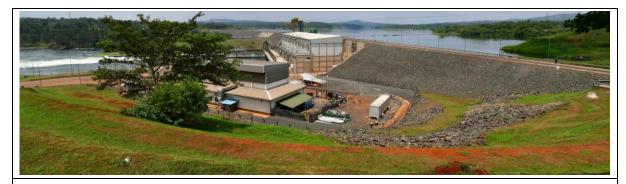
Left embankment dam downstream face (from BEL Office)

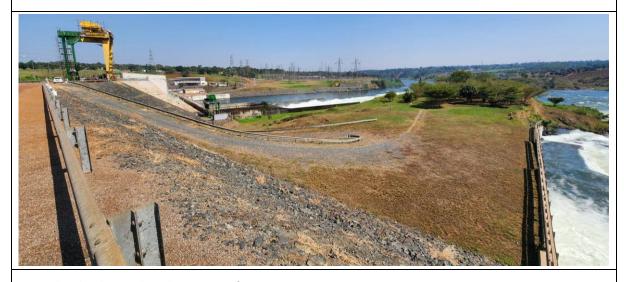
Central embankment dam downstream face

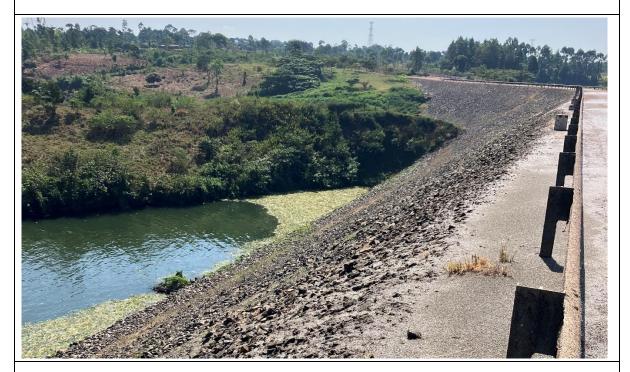
Right embankment dam downstream face

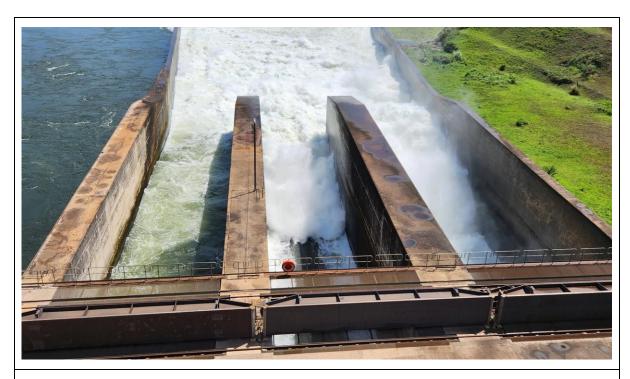
Gated spillway (outlet channel, two radial gate bays (left and central bays), and flap gate on right)

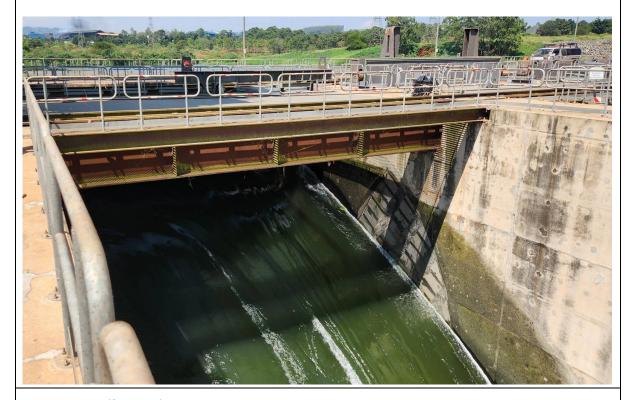
Gated spillway (flap gate)

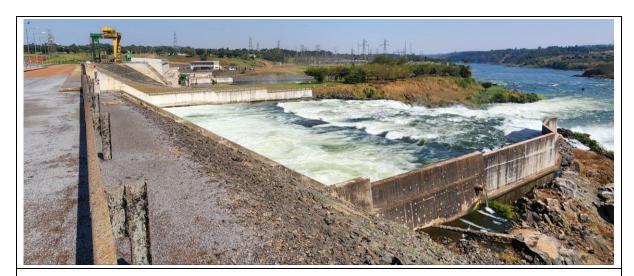
Siphon spillway outlet channel (looking to left bank and downstream)

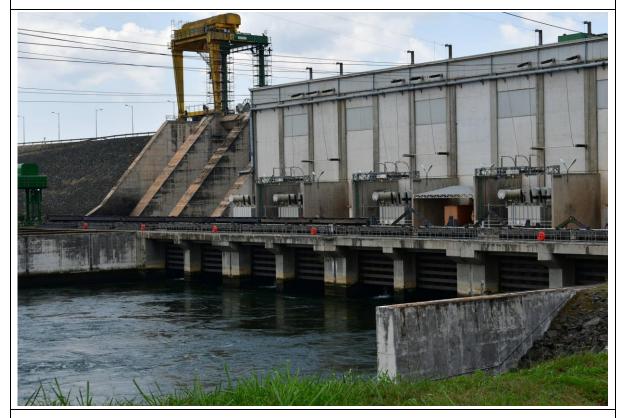
Power station tailbay/tailrace

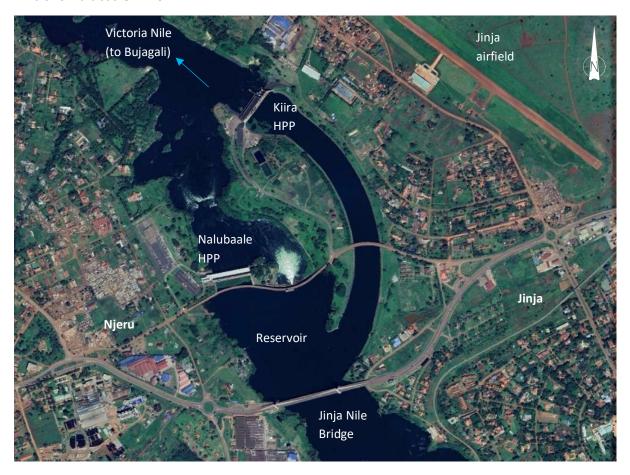
Figure 1.5 General layout of the Owen Falls Complex (Nalubaale and Kiira HPPs)

Nalubaale HPP is a concrete gravity dam with sluiceways (6 No. and an inline power station (10 No. 18 MW turbines, total capacity of $1200 \, \text{m}^3/\text{s}$). Kiira HPP features a headrace canal with earthcore rockfill dams, an inline power station (5 No. 40 MW turbines) ($1100 \, \text{m}^3/\text{s}$ capacity) and spillway gates (3 No. radial gates). The combined generation discharge is $2300 \, \text{m}^3/\text{s}$, and the combined spillway discharge is $2940 \, \text{m}^3/\text{s}$, from the Owen Falls complex. The design IDF for Bujagali Dam is $4500 \, \text{m}^3/\text{s}$, which is a flow that can only be realised if both spillways are discharging at the same time as both power stations at maximum generation.

To aid event coordination between the cascade scheme operators, and for the purposes of this EPRP, an overview of the Owen Fall Complex is provided below. Figure 1.5 shows the general layout of the Kiira and Nalubaale HPPs.

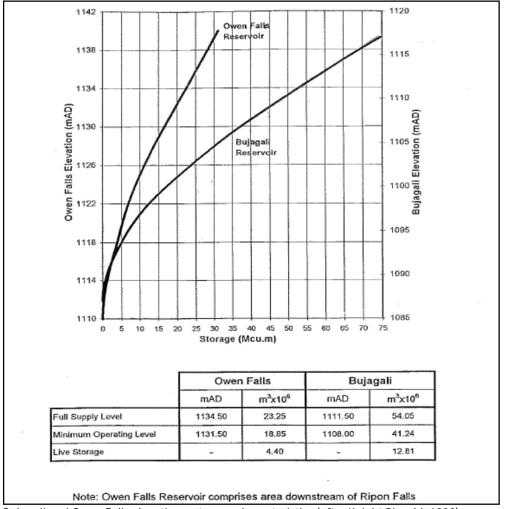
Bujagali and Owen Falls elevation – storage characteristics (after Knight Piesold, 1998)

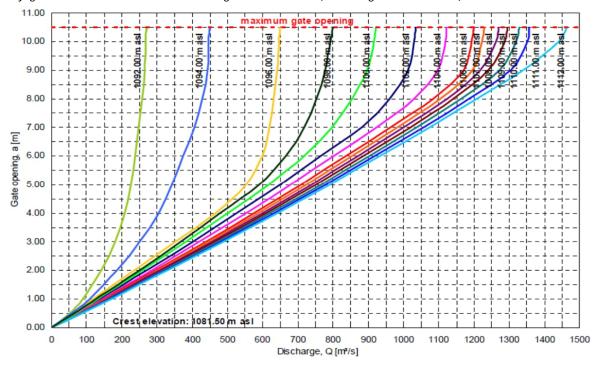
Radial sluice gate discharge through versus gate opening for range of reservoir levels for one gate (from Fichtner, 2007)

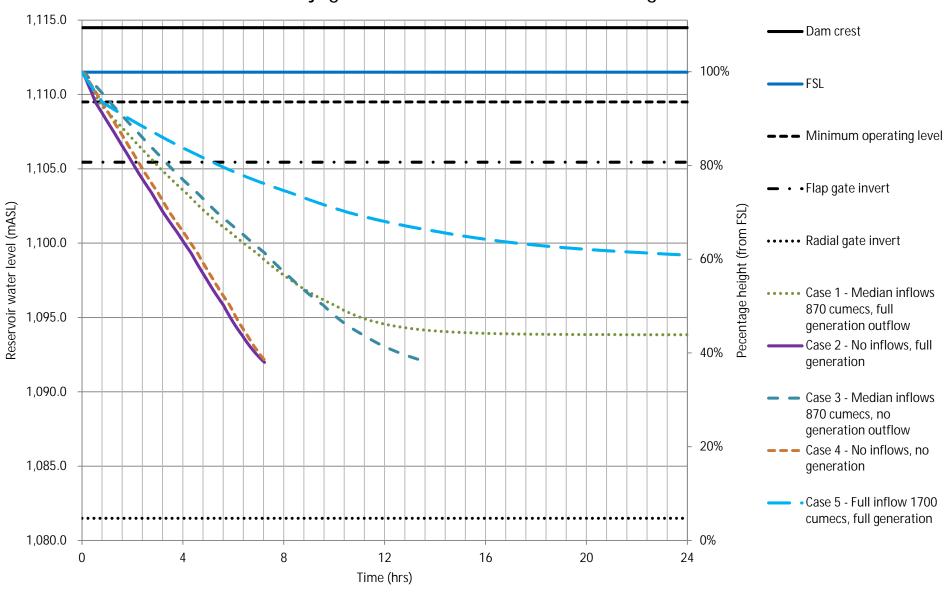
Calculated Bujagali Reservoir Water Level During Drawdown

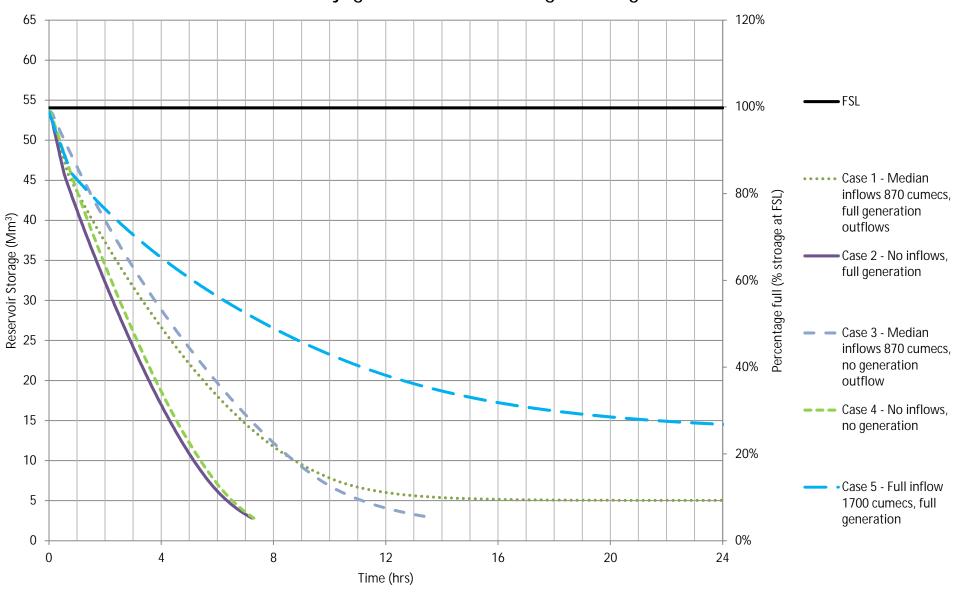
Calculated Bujagali Reservoir Storage During Drawdown
